# NATIONAL TRANSPORTATION SAFETY BOARD

## Onboard Image Recorder

Specialist's Factual Report  
By Sean Payne

Location: Crozet, Virginia  
Date: January 31, 2018  
Train: Locomotive 145, Train 923 (Lead)  
Operator: Amtrak  
NTSB Number: HWY18MH005

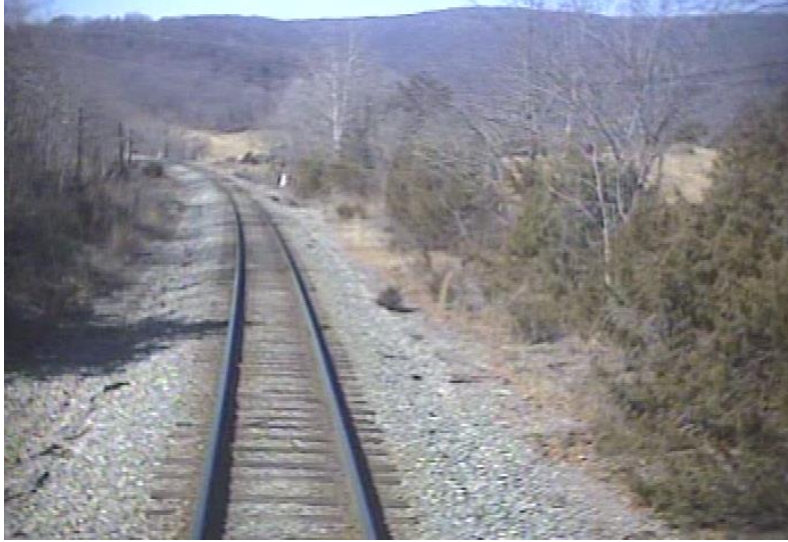
Around 11:16:19, the train was rounding a curve and the horn was audible. Figure 1 is a screenshot from this time

**Figure 1. The train at 11:16:19, when it was rounding a curve and the horn was audible.**

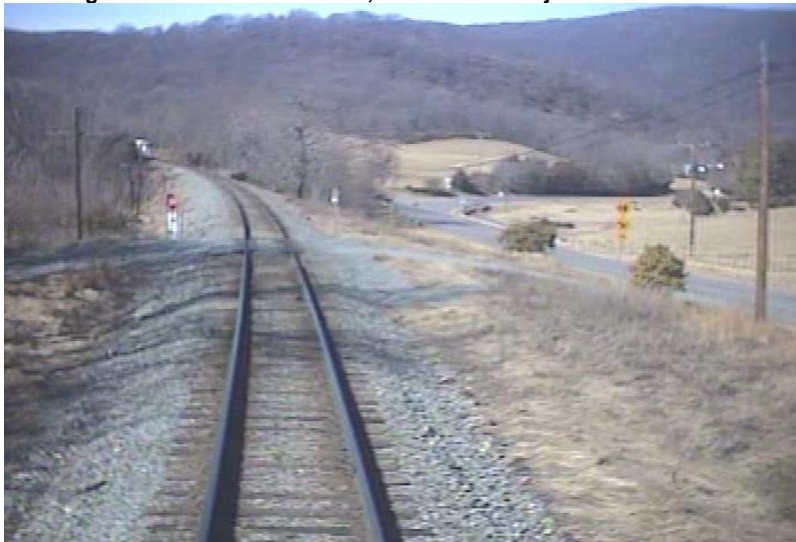
Around 11:16:26, the train was passing a smaller grade crossing (8<sup>th</sup> grade crossing since the start of the recording) and a white object came into the camera's view beyond a line of trees around the oncoming curve. The horn was almost continually audible as the train approached this grade crossing. Figure 2 is a screenshot at this time.

**Figure 2. The train at 11:16:26, when a white object came into view.**

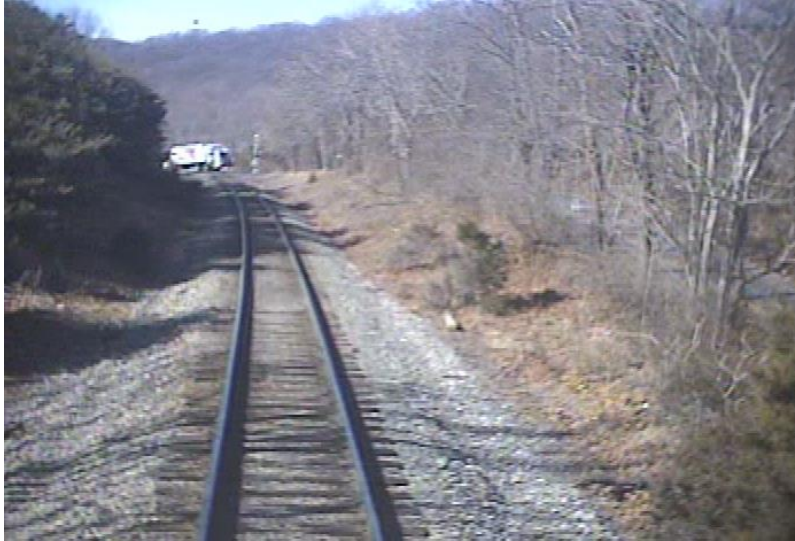
The horn was continuously audible through the time of impact. Figure 3 is a screenshot captured at 11:16:33 when the white object clearly appeared to be a garbage truck. The garbage truck was beyond the crossing gate (crossing gate on the right side of the track as viewed from the locomotive). The lights on the crossing gate were flashing.

**Figure 3. The train at 11:16:33 when the garbage truck was clearly visible.**

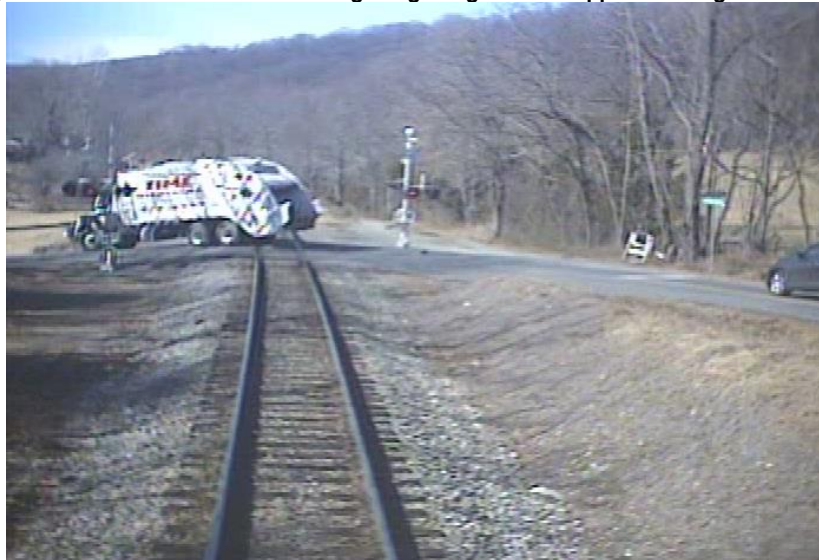
Two seconds later, at 11:16:35, the garbage truck appeared to stop on the grade crossing (9<sup>th</sup> grade crossing since the start of the recording). The lights on the crossing gate were flashing and the crossing gate on the right of the track was clearly down.

The horn continued to be audible. Figure 4 is a screenshot captured at 11:16:37, with the garbage truck stopped on the grade crossing.

**Figure 4. The train at 11:16:37 showing the garbage truck stopped on the grade crossing.**

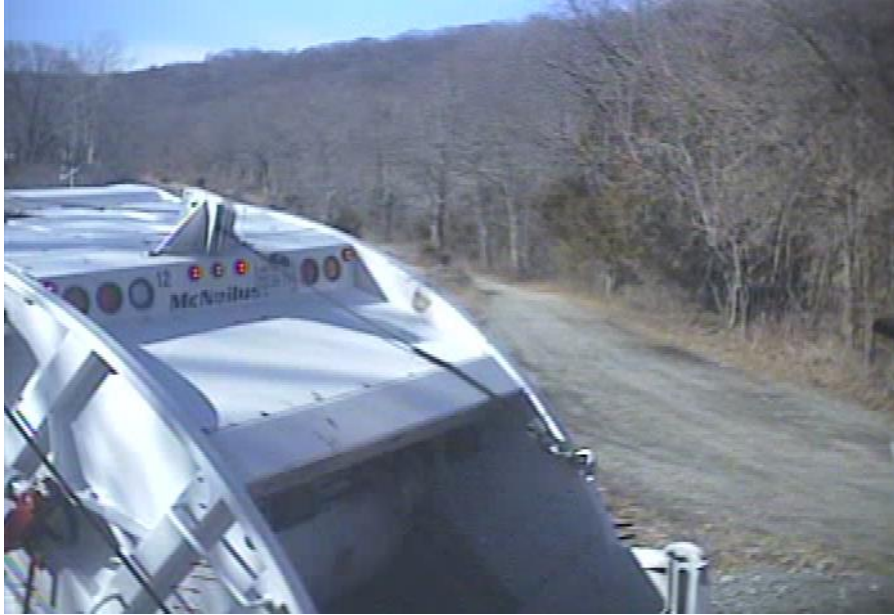
Figure 5 shows the moment of impact at 11:16:38, with the horn continuously audible.

Figure 5. Impact at 11:16:38.
